TECHNICAL MEMORANDUM

" RUNWAY FRICTION MEASUREMENT AND PAVEMENT CONDITION
SURVEY, USNOLE SAN NICOLAS ISLAND, CALIFORNIA- by

R. B. BROWNIE ,

FEBRUARY 1977, "

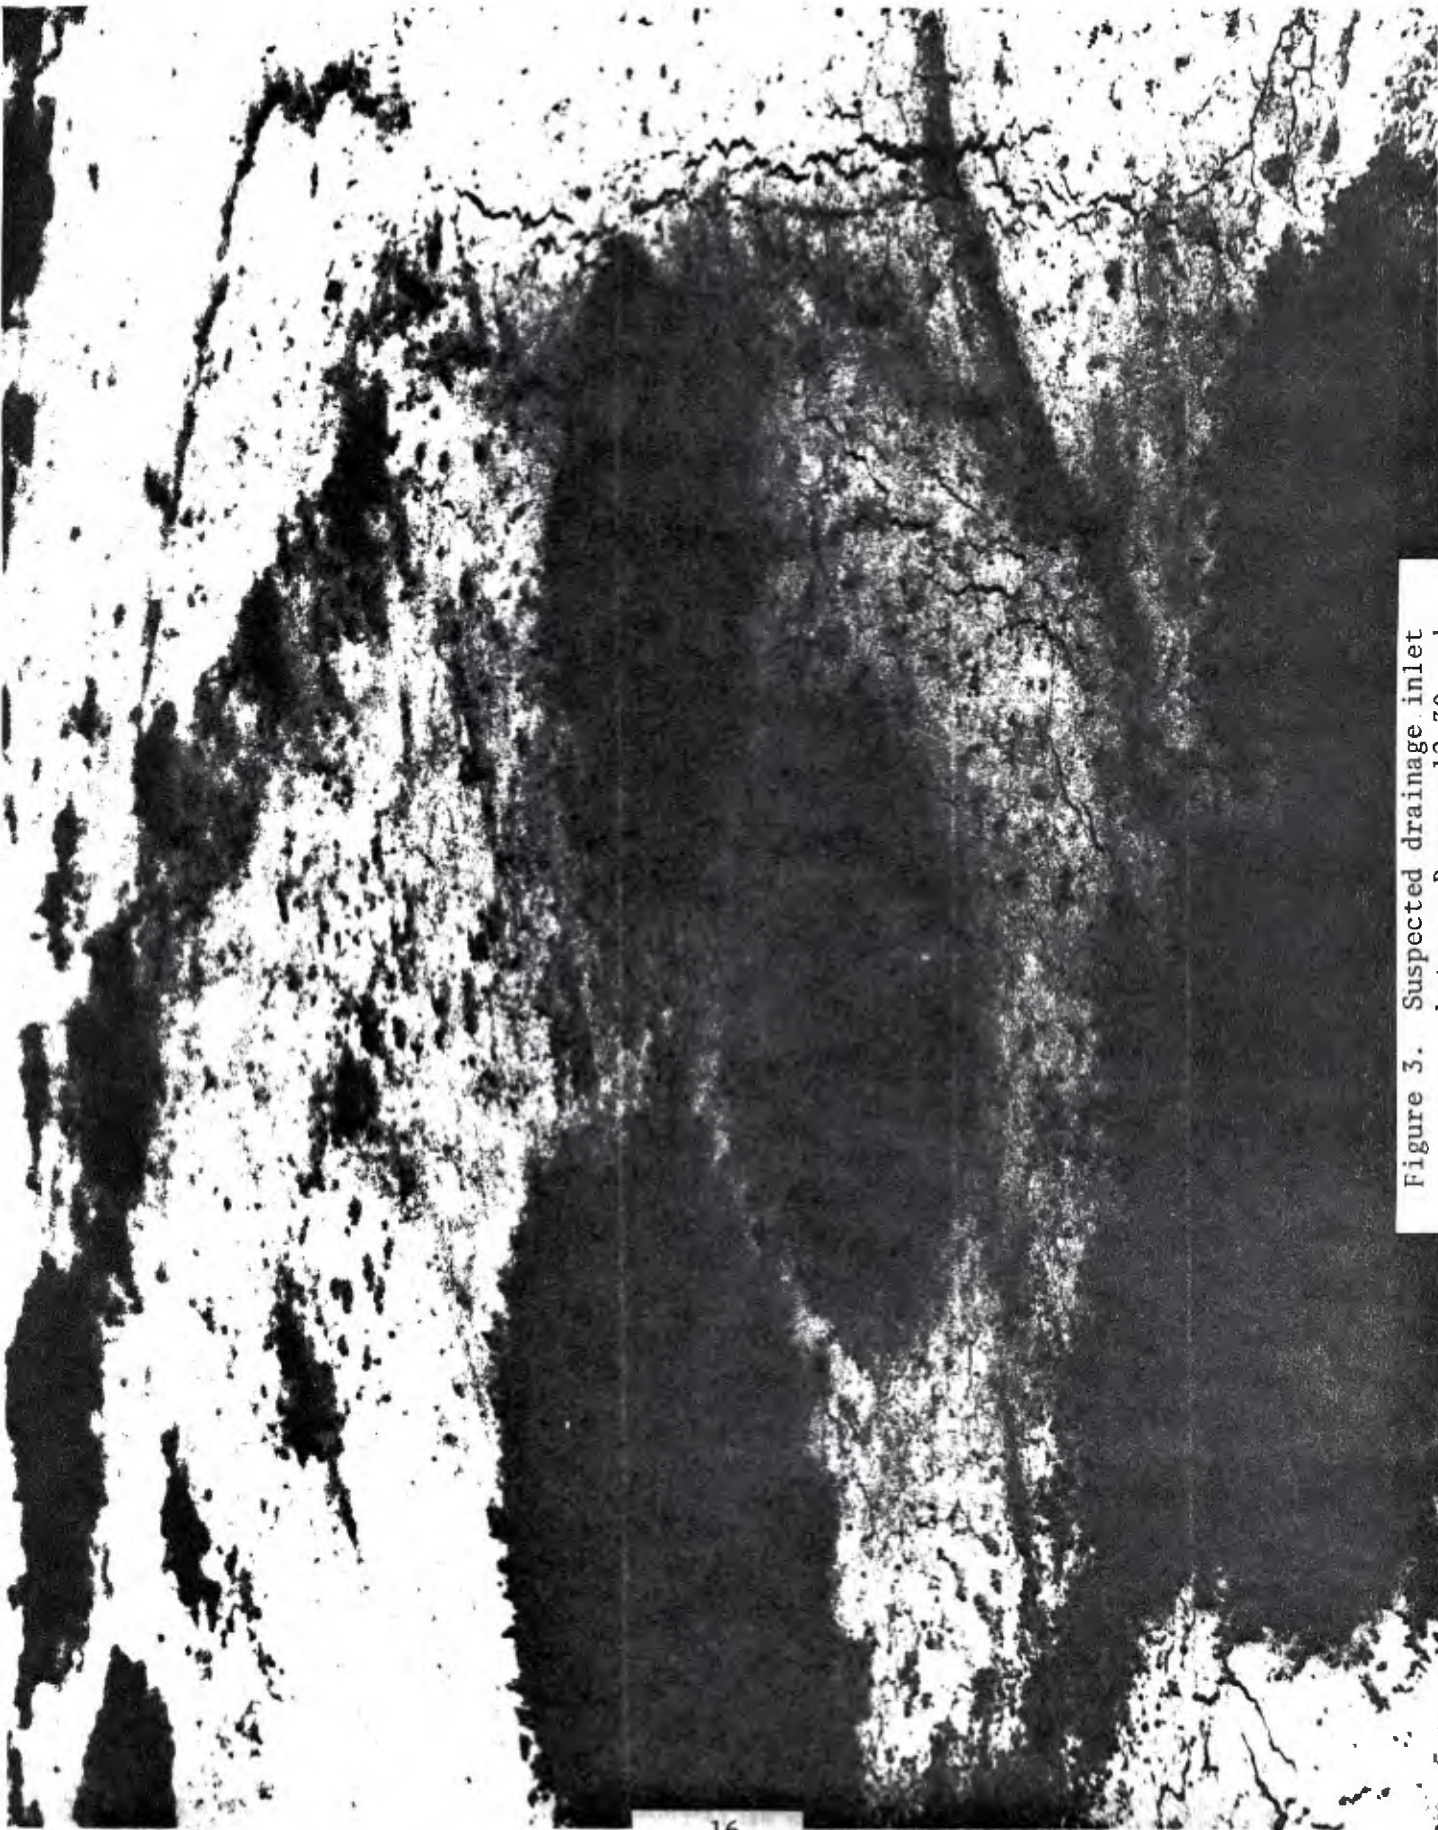
R12-1: The slight increase in the amount of longitudinal construction joint cracking is attributed to aging of the pavement surface. The increased amount of patching was the result of utility trench construction.

Figure 2. Typical longitudinal joint cracks. Discrete Area R12-1

It is recommended that consideration be given to correcting the lack of pavement surface texture and ponding water. Suggested corrective measures include a porous friction surface or a slurry seal specifically designed to provide adequate surface texture. Depressed areas which cause ponding of water should be surveyed and brought up to the proper grade with a leveling course of asphaltic concrete. A slurry seal would have the additional benefit of sealing the cracks noted in the runway.
